Multiple Mitigation Measures Ease Town's Trouble

Waldo County, ME - Lake St. George in the Town of Liberty is reported by local officials to be one of the cleanest lakes in Maine. If you were in the area on a sunny summer day you would find as many as 150 people swimming, fishing, and picnicking on its banks. The lake is big area attraction for locals, tourists, and vacationers from far away.

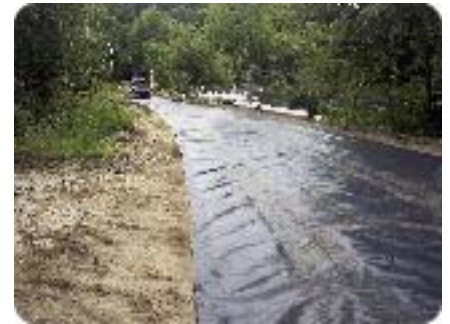
However, when the weather was severe and the crowds were gone, a local road on the edge of the lake presented problems. Stickney Hill Road, a steep incline, which runs very close to the shore along the southern end of Lake St. George, created extreme hazards for travelers and threatened the purity of the lake itself. In all seasons, winter ice storms, freezing and thawing, spring runoff, summer repetitive flooding, and fall heavy rain events had washed out shoulders, eroded the roadway, blocked culverts causing embankment erosion, and deposited extensive silt, debris, and sediment in the lake.

The solution to the problem involved multiple mitigation measures. First, 900 feet of the old road surface was removed. The roadbed was then lined with geotextiles, a permeable fabric engineered to control drainage and to keep the water table from rising above the road. When used in association with stone and soil, geotextiles have the ability to separate, filter, reinforce, protect, or drain water from an area. The ditches on either side of the road were also lined with geotextiles and stone.

Six driveway culverts along the road were also increased in sized. Under the road, three cross culverts with plunge pools were installed to collect runoff and sediment. After all 900 feet of road was elevated 14 inches and repaved, the shoulders on both sides of the road were then loamed and seeded. Rip-rap was also placed along the shoreline of the lake.
